ANALYSIS OF TREES AT

1332 35TH AVENUE SOUTH
SEATTLE, WA 98144-4002

February 18, 2011

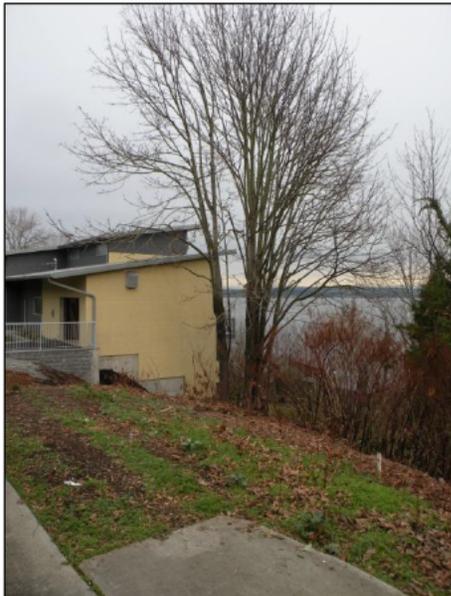
Photo # 2: Tree # 455 and the new addition of the house to the north

Trees 450 & 457 and 461 will likely all have to be removed for the safety of construction workers, the new home, its new occupants and guests. The remaining trees may or may not have to be removed depending upon how large the new house is and whether any are within striking distance of the new house or surrounding high use areas. That determination will need to be made once the final design has been completed.

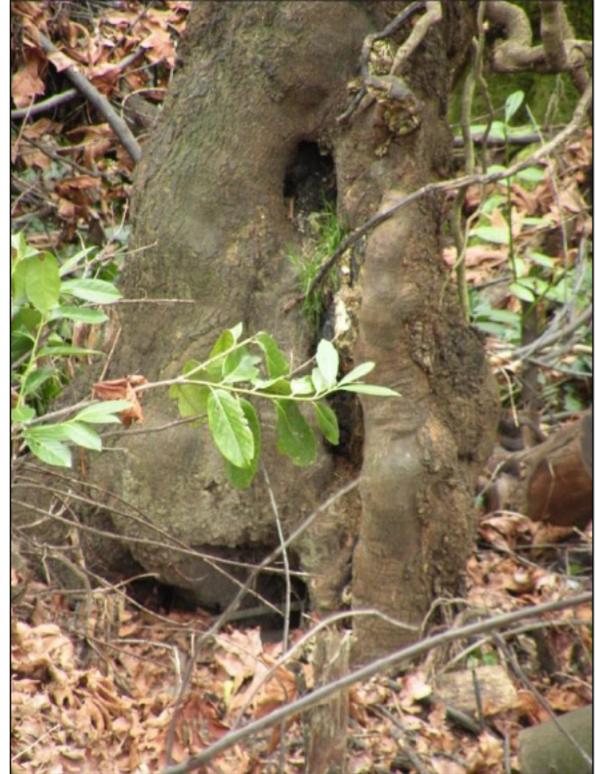
Photo # 4: the base of another Maple—typical of all the Maples with extensive internal decay extending down into the base
