ANALYSIS OF TREES AT

1332 35TH AVENUE SOUTH
SEATTLE, WA 98144-4002

February 18, 2011

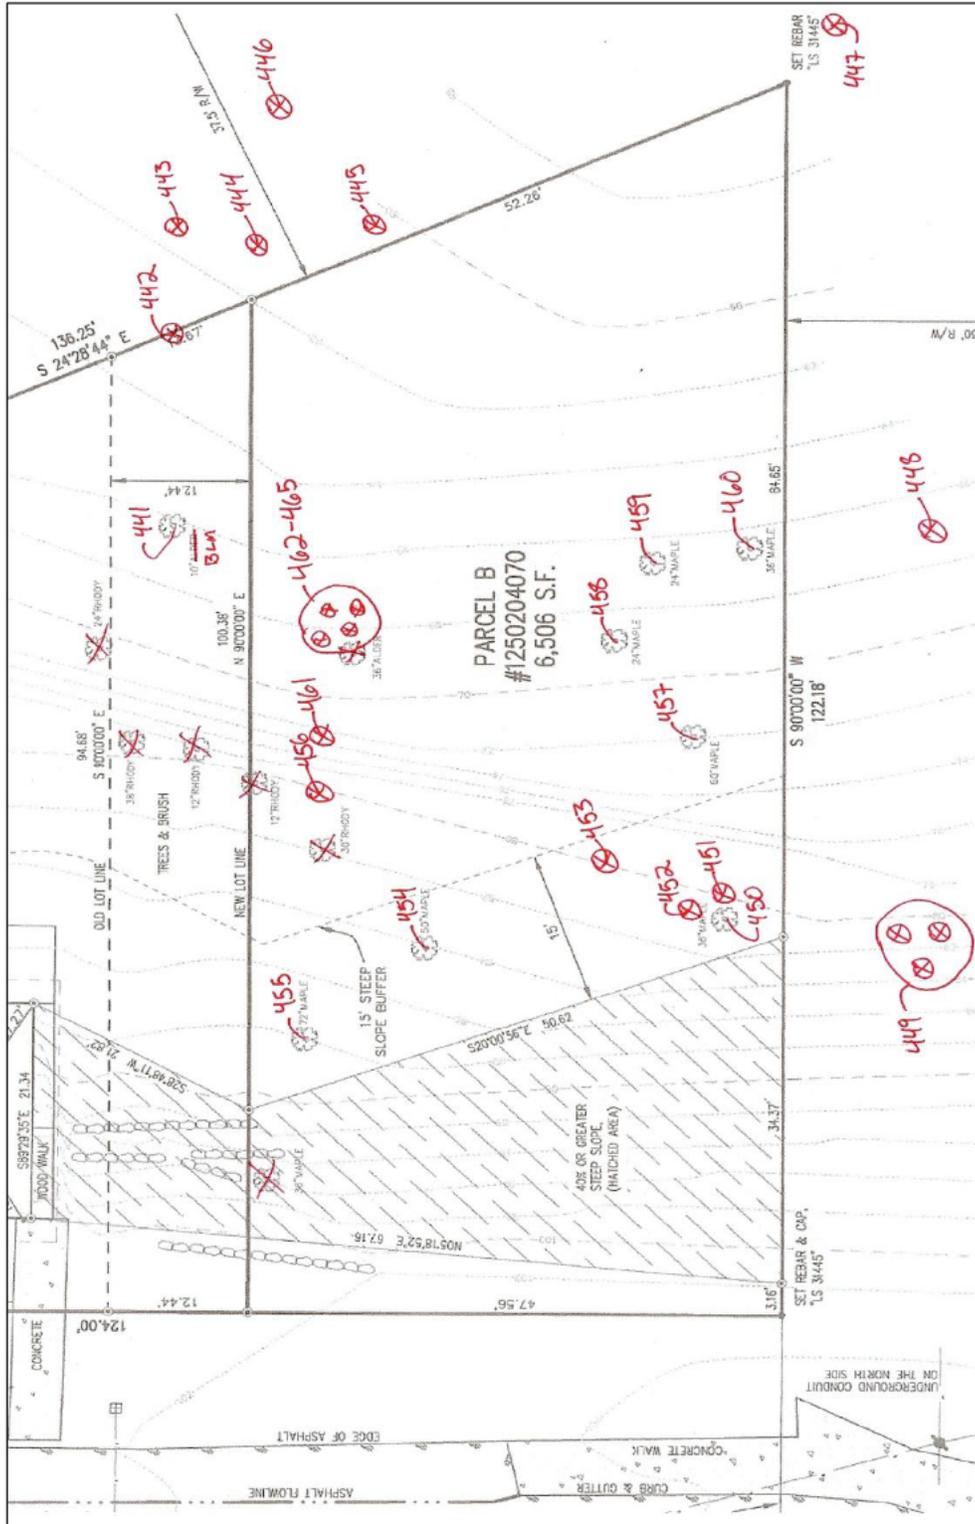
ATTACHMENT 1 - SITE PLAN

- The are all in poor condition.	
- However, they appear that they will not be impacted by the house construction.	
- There are 6 trees off the subject property to the North and east.

- Of the 6 trees only # 441 at the top of the steep bank to the north is in Fair condition. The other 5 are in poor condition.	
- All 6 trees can be adequately protected with tree protection fence along the Temporary Erosion Control & Sedimentation Fence.

- Subject Property Trees:	
- 16 trees were evaluated on the subject property	
- Status:	
- All 16 trees were found to be in poor health, poor vigor, poor structure, or a combination of factors.

- 1 Tree is dead.	
- 4 Trees are dying.	
- 11 Trees are in Poor condition.	
- Therefore, all 16 trees are <i>Non-Significant</i> . There are no <i>Exceptional Trees</i> on the property or adjacent right-of-way.

Only one of the 25 trees evaluated was rated as Fair. It is # 441 on the neighbor's property to the north. All the other trees were rated as Dead, Dying, or Poor. Most will need to be removed for safety. Once the house design is finalized a decision on all of the trees can be made. Once the decision to remove trees has been made this should be run past the geotechnical engineer to decide if there are any negative impacts on the soil stability. The landscape architect will need to know of any requirements by the City to install replacement trees both on the subject property and the right-of-way.
